Categorical Exclusion

Appendix F

Waters of the U.S. Determination Report
Marshall Co. Bridge #73
Marshall County, Indiana
Des. No. 1600931

Waters of the U.S. Determination Report
Marshall Co. Bridge #73 – Bridge Replacement Project
Marshall County, Indiana
Des. No. 1600931

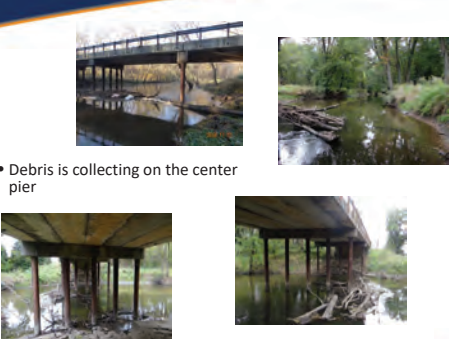
Debris Collecting on Center Pier

- Debris is collecting on the center pier

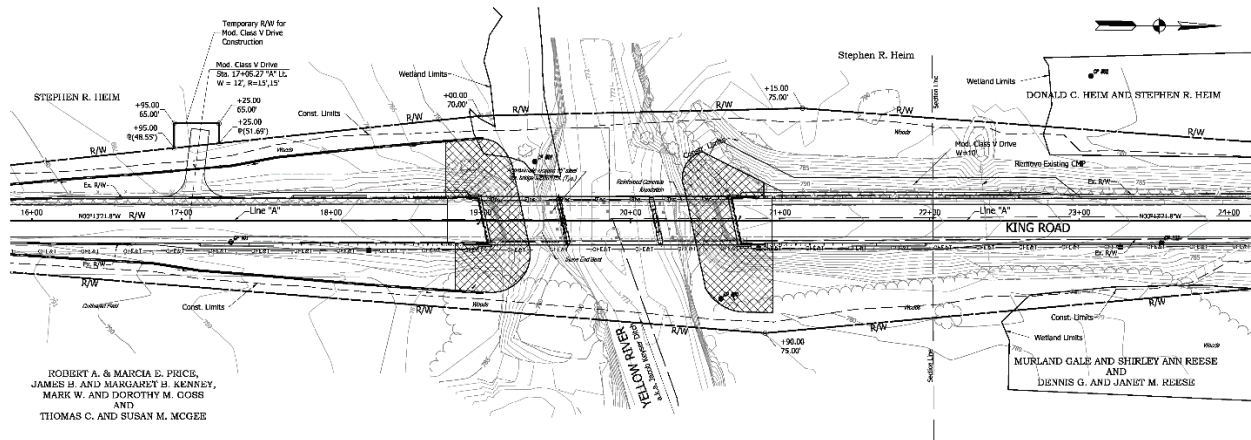
Proposed bridge layout

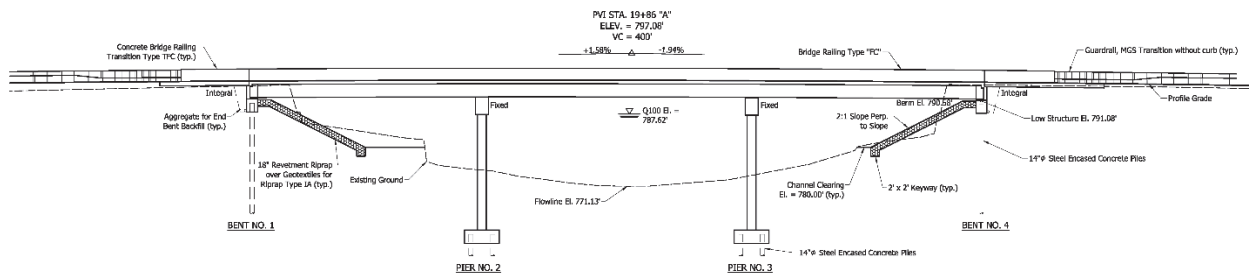
Proposed bridge profile

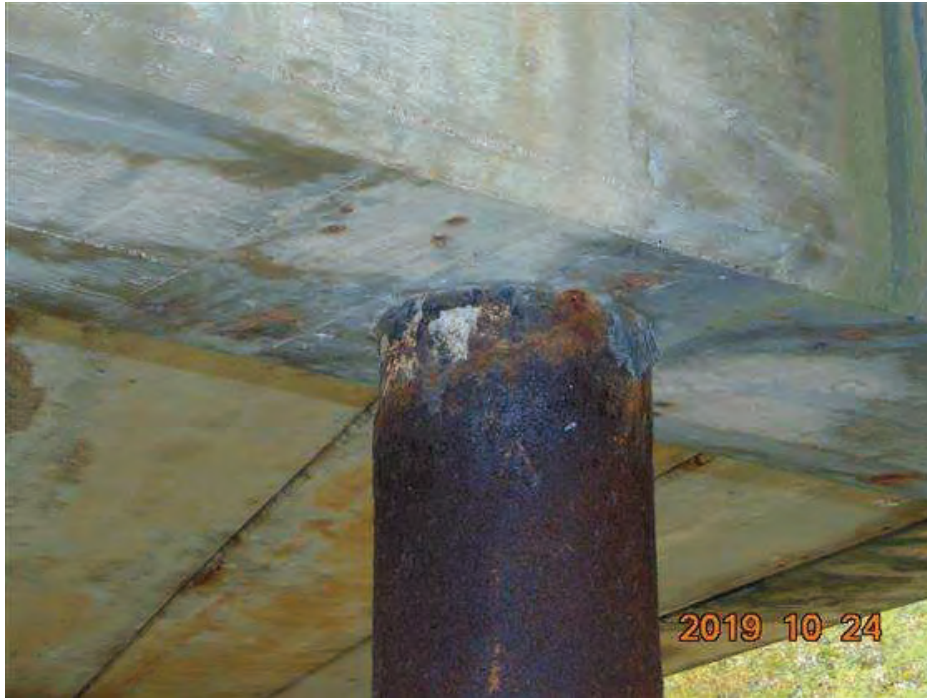
PHOTO 3

Description Looking at Bent 2 Pile Rust Through

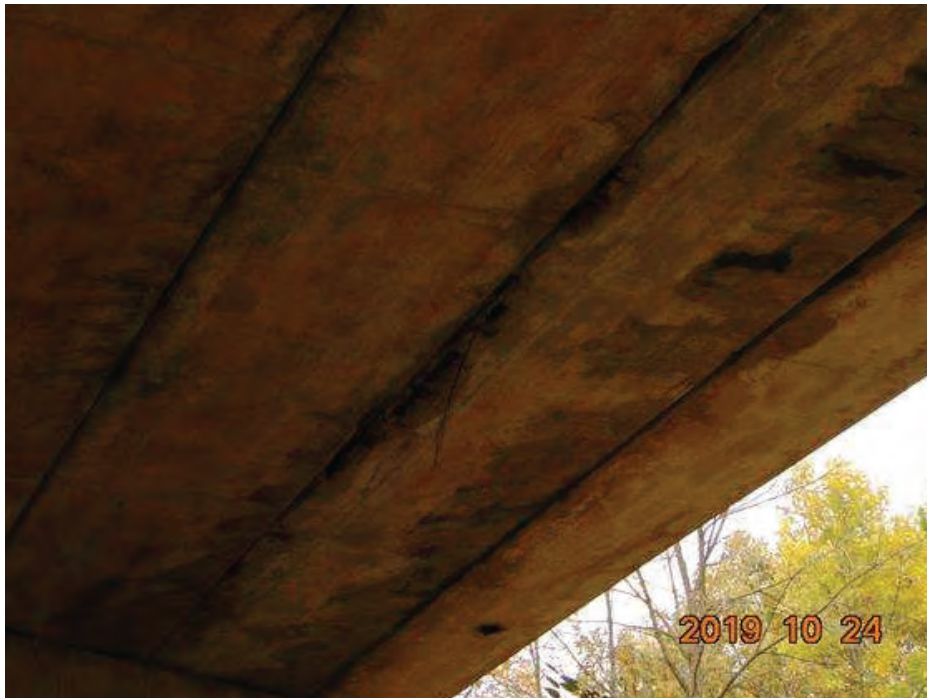
PHOTO 4

- Various bridge beams are deteriorated and have exposed or broken strands

Description Beam D2 - Deterioration Hanging Strands

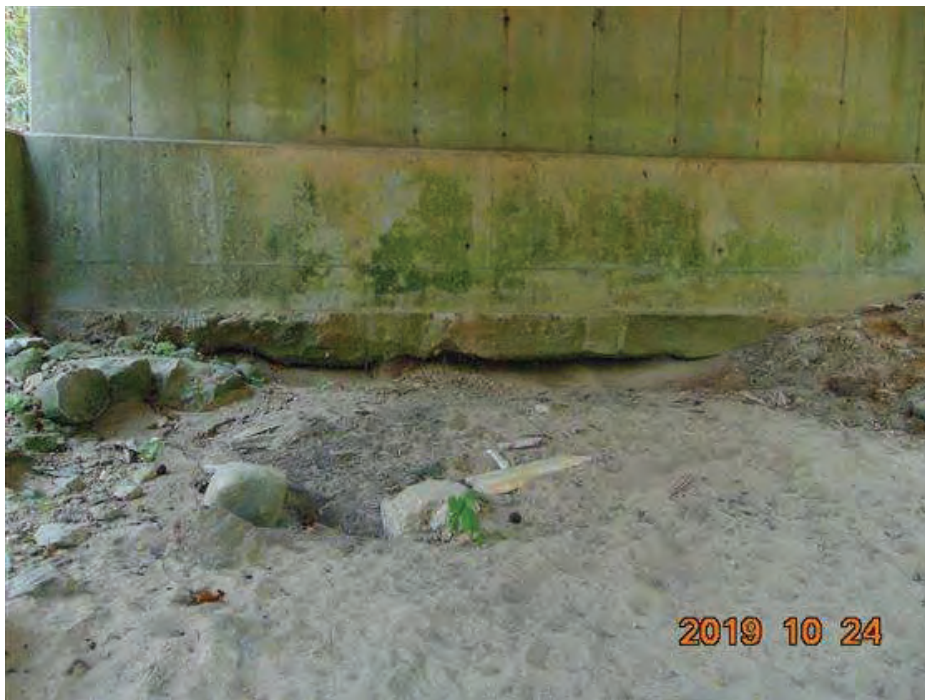
PHOTO 7

Description End Bent 5 Deterioration due to Socur

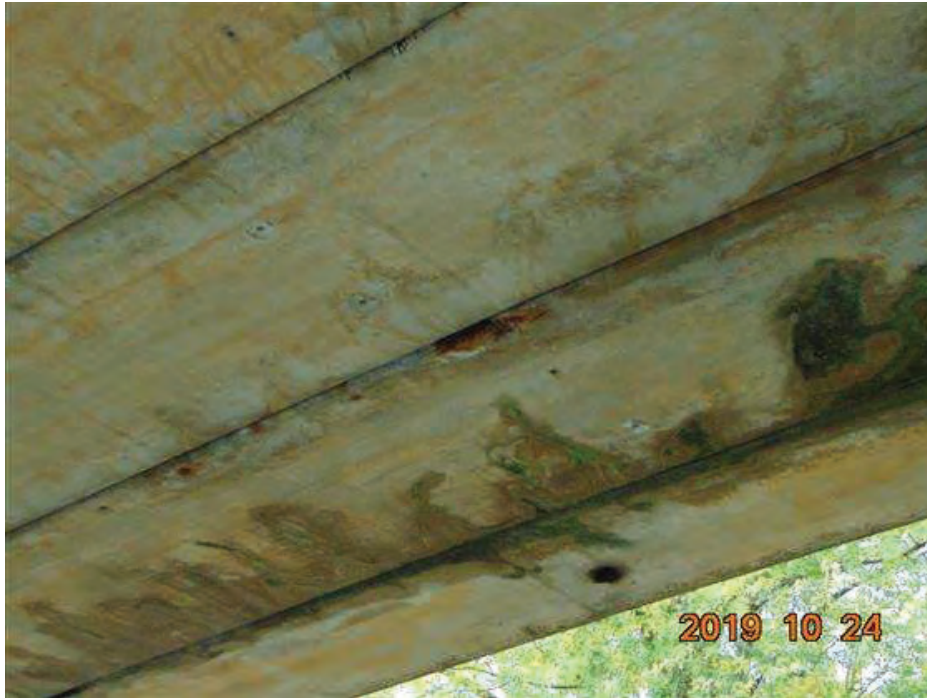
PHOTO 11

Description Looking at Beam C2 - Spalling

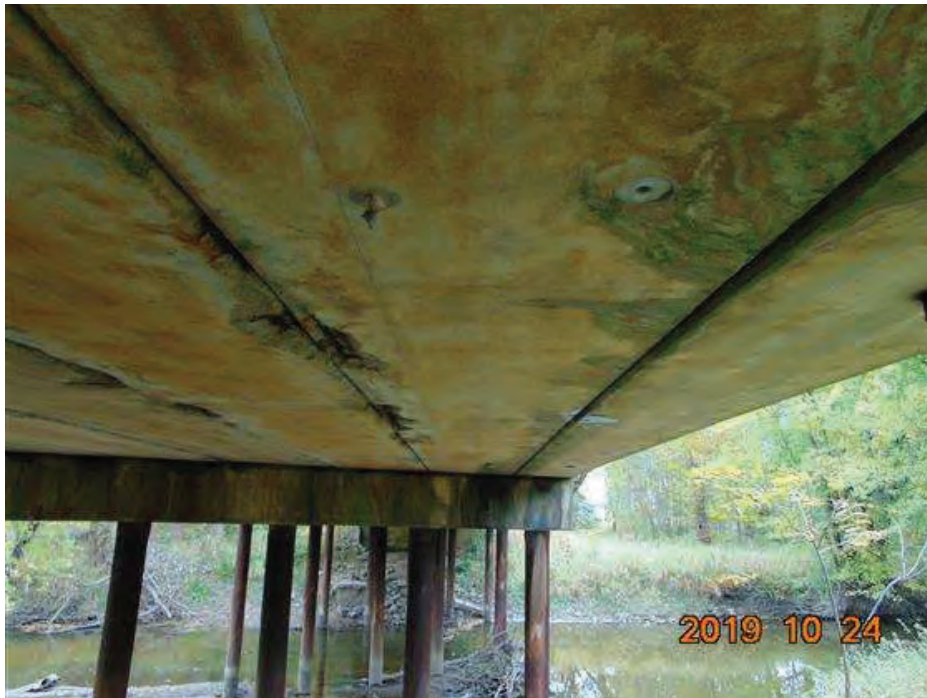
PHOTO 12

Description Looking at Beams A3-4 - Spalls

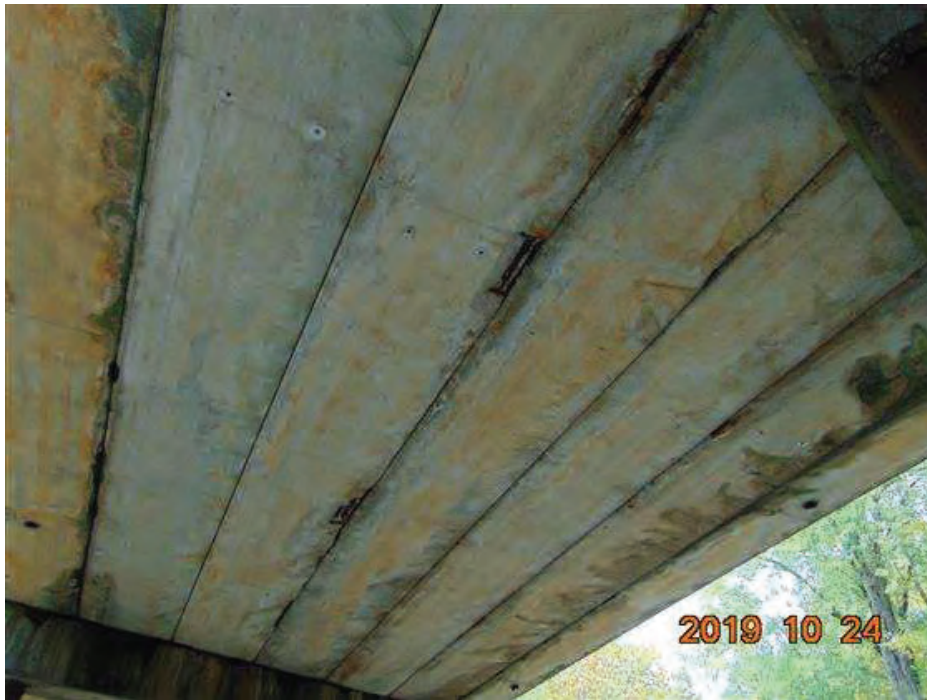
PHOTO 18

Description Looking at Beams C4 & C5 - Spalling

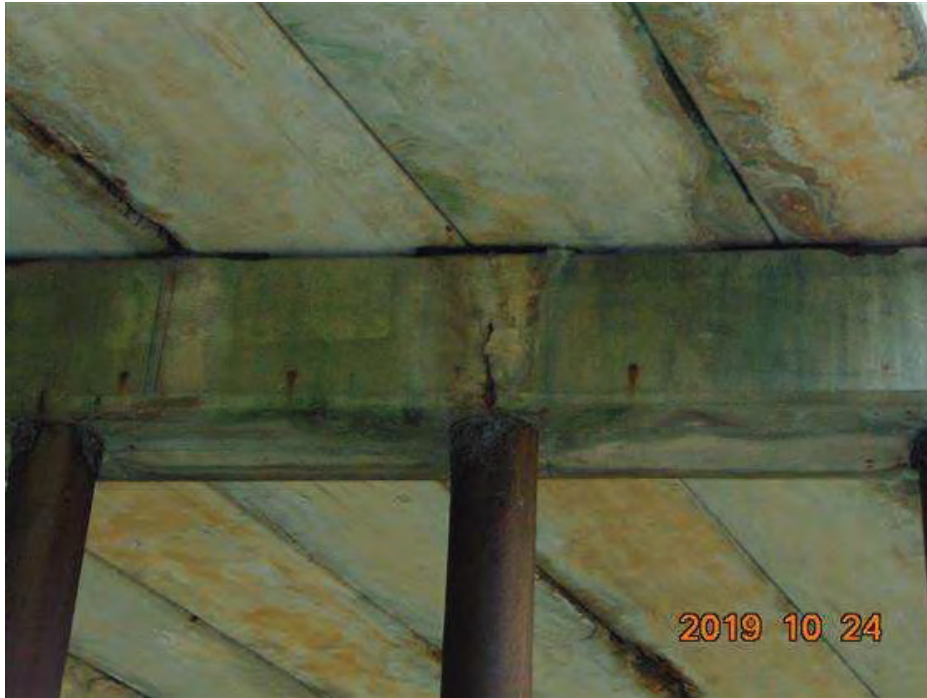
PHOTO 25

Description Looking at Bent 4 - Spalling

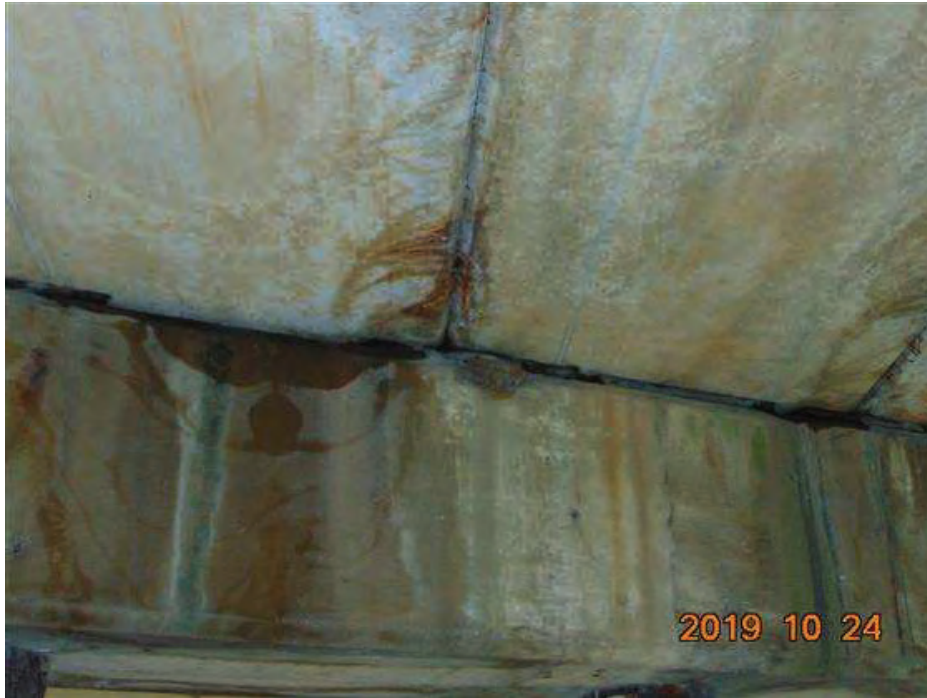
PHOTO 31

Description Nest on Bent 2 between Beams A4 and A5

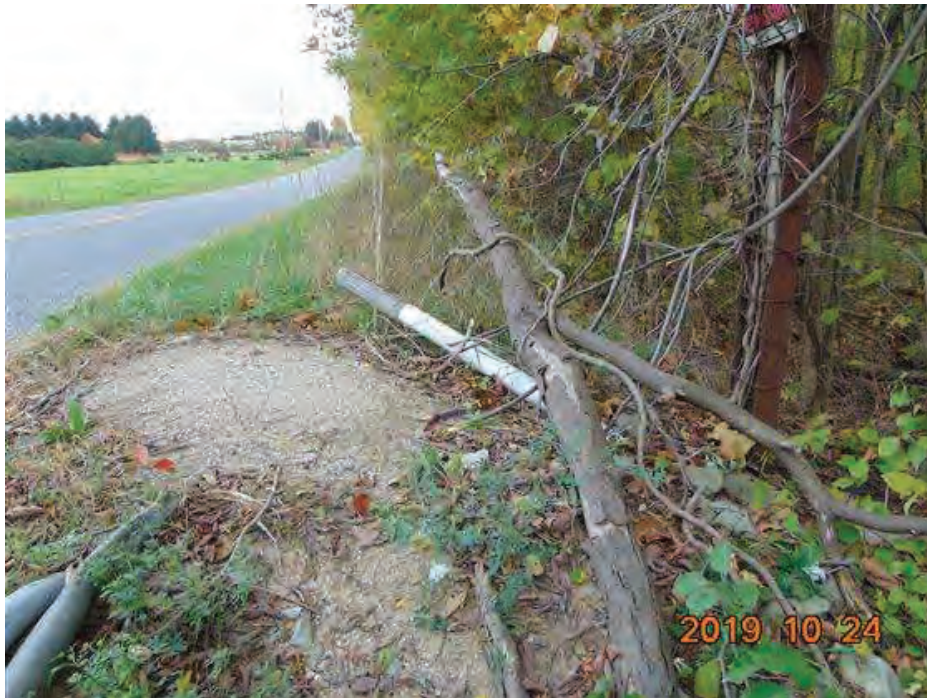
PHOTO 34

Description South Approach (West) Downed Utility Locator

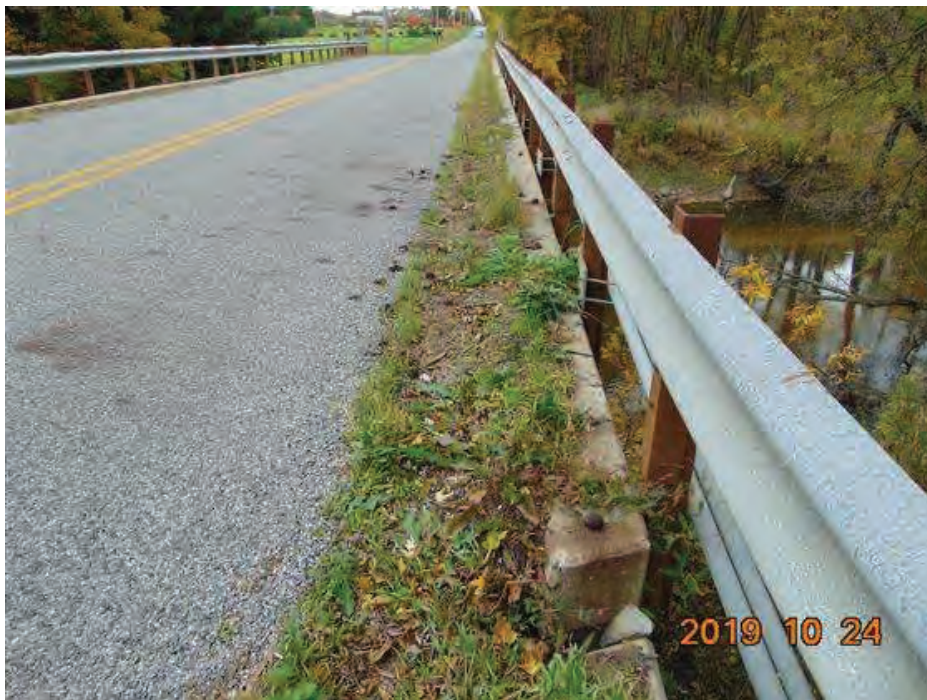
PHOTO 36

Description Vegetation on East Shoulder Looking North

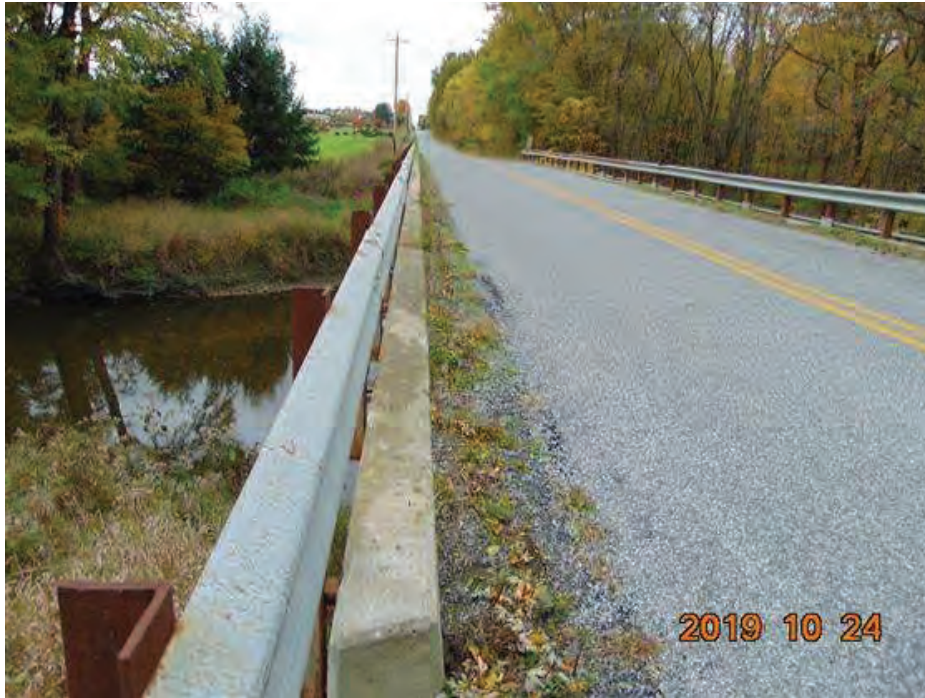
PHOTO 37

Description Vegetation on West Shoulder Looking North

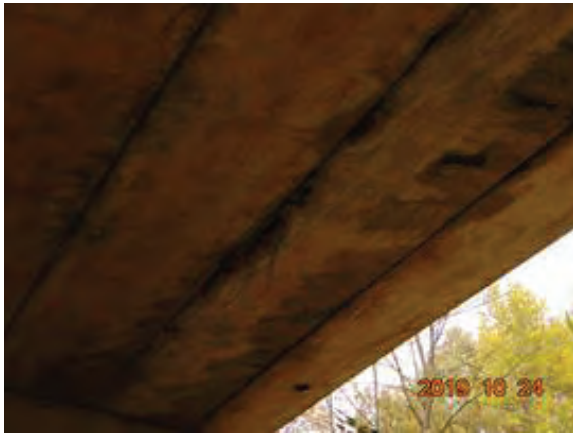
File Description Beam D2 -
Deterioration
Hanging
Strands

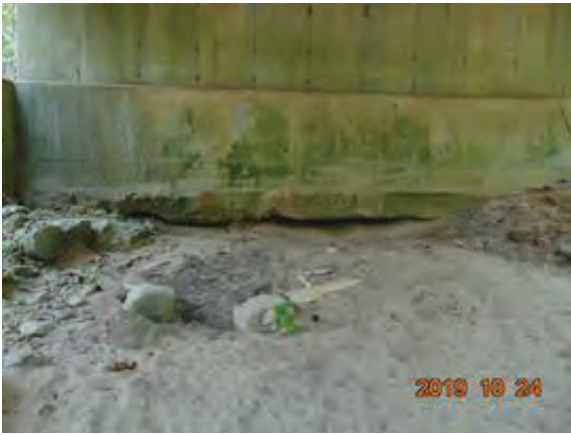
File Description End Bent 5
Deterioration
due to Socur

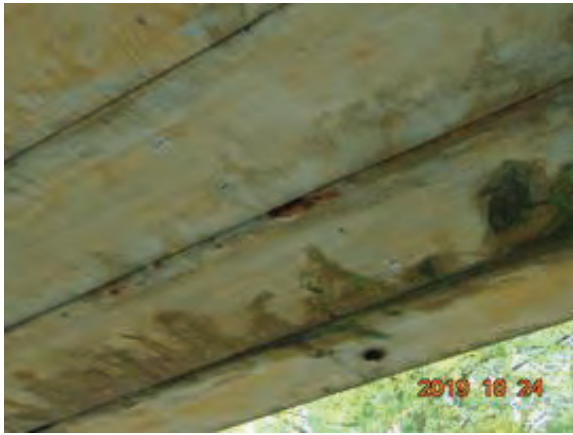
File Description Looking at
Beam C2 -
Spalling

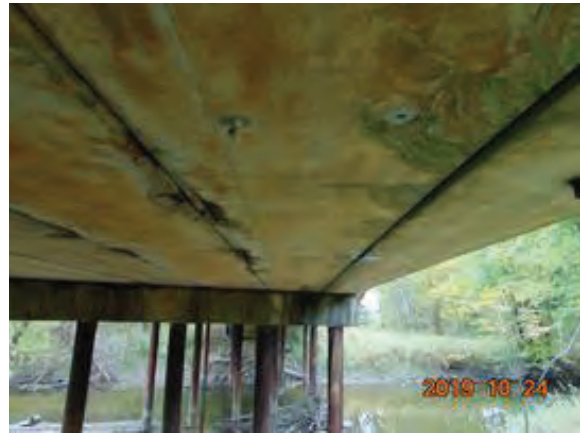
File Description Looking at
Beams A3-4 -
Spalls

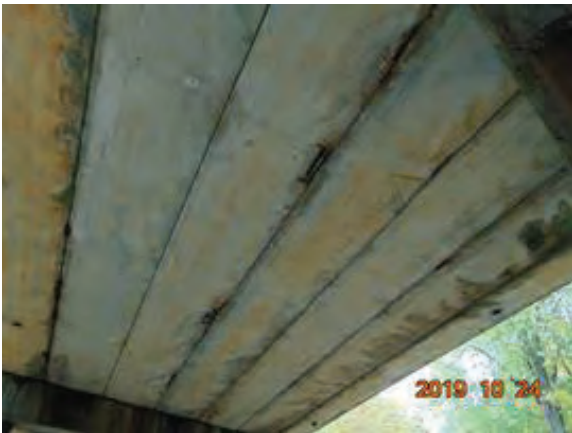
File Description Looking at
Beams C4 &
C5 - Spalling

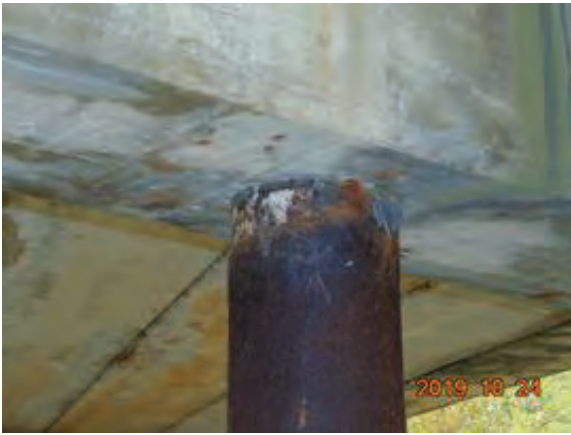
File Description Looking at Bent
2 Pile Rust
Through

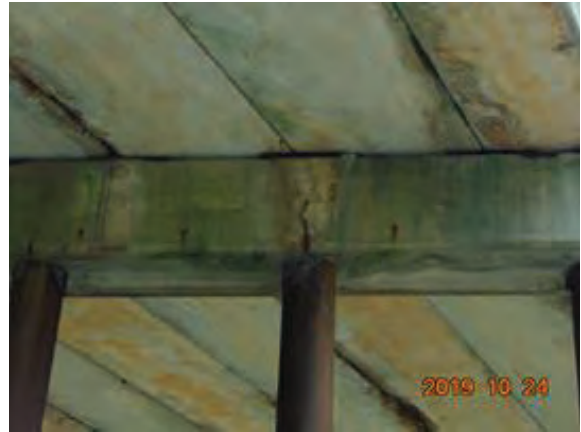
File Description Looking at Bent
4 - Spalling
